**PROJECT:**  
WESTWAY PLACE BOTLEY BLOCK F

**TITLE:**  
BRICKWORK SETTING OUT ELEVATIONS

<b>DRAWING No:</b>	PROJECT:	ORG:	ZONE:	LEVEL:	TYPE:	ROLE:	NUMBER:	REV:
5005932	RDG	XX	XX	EL	A	0127	F

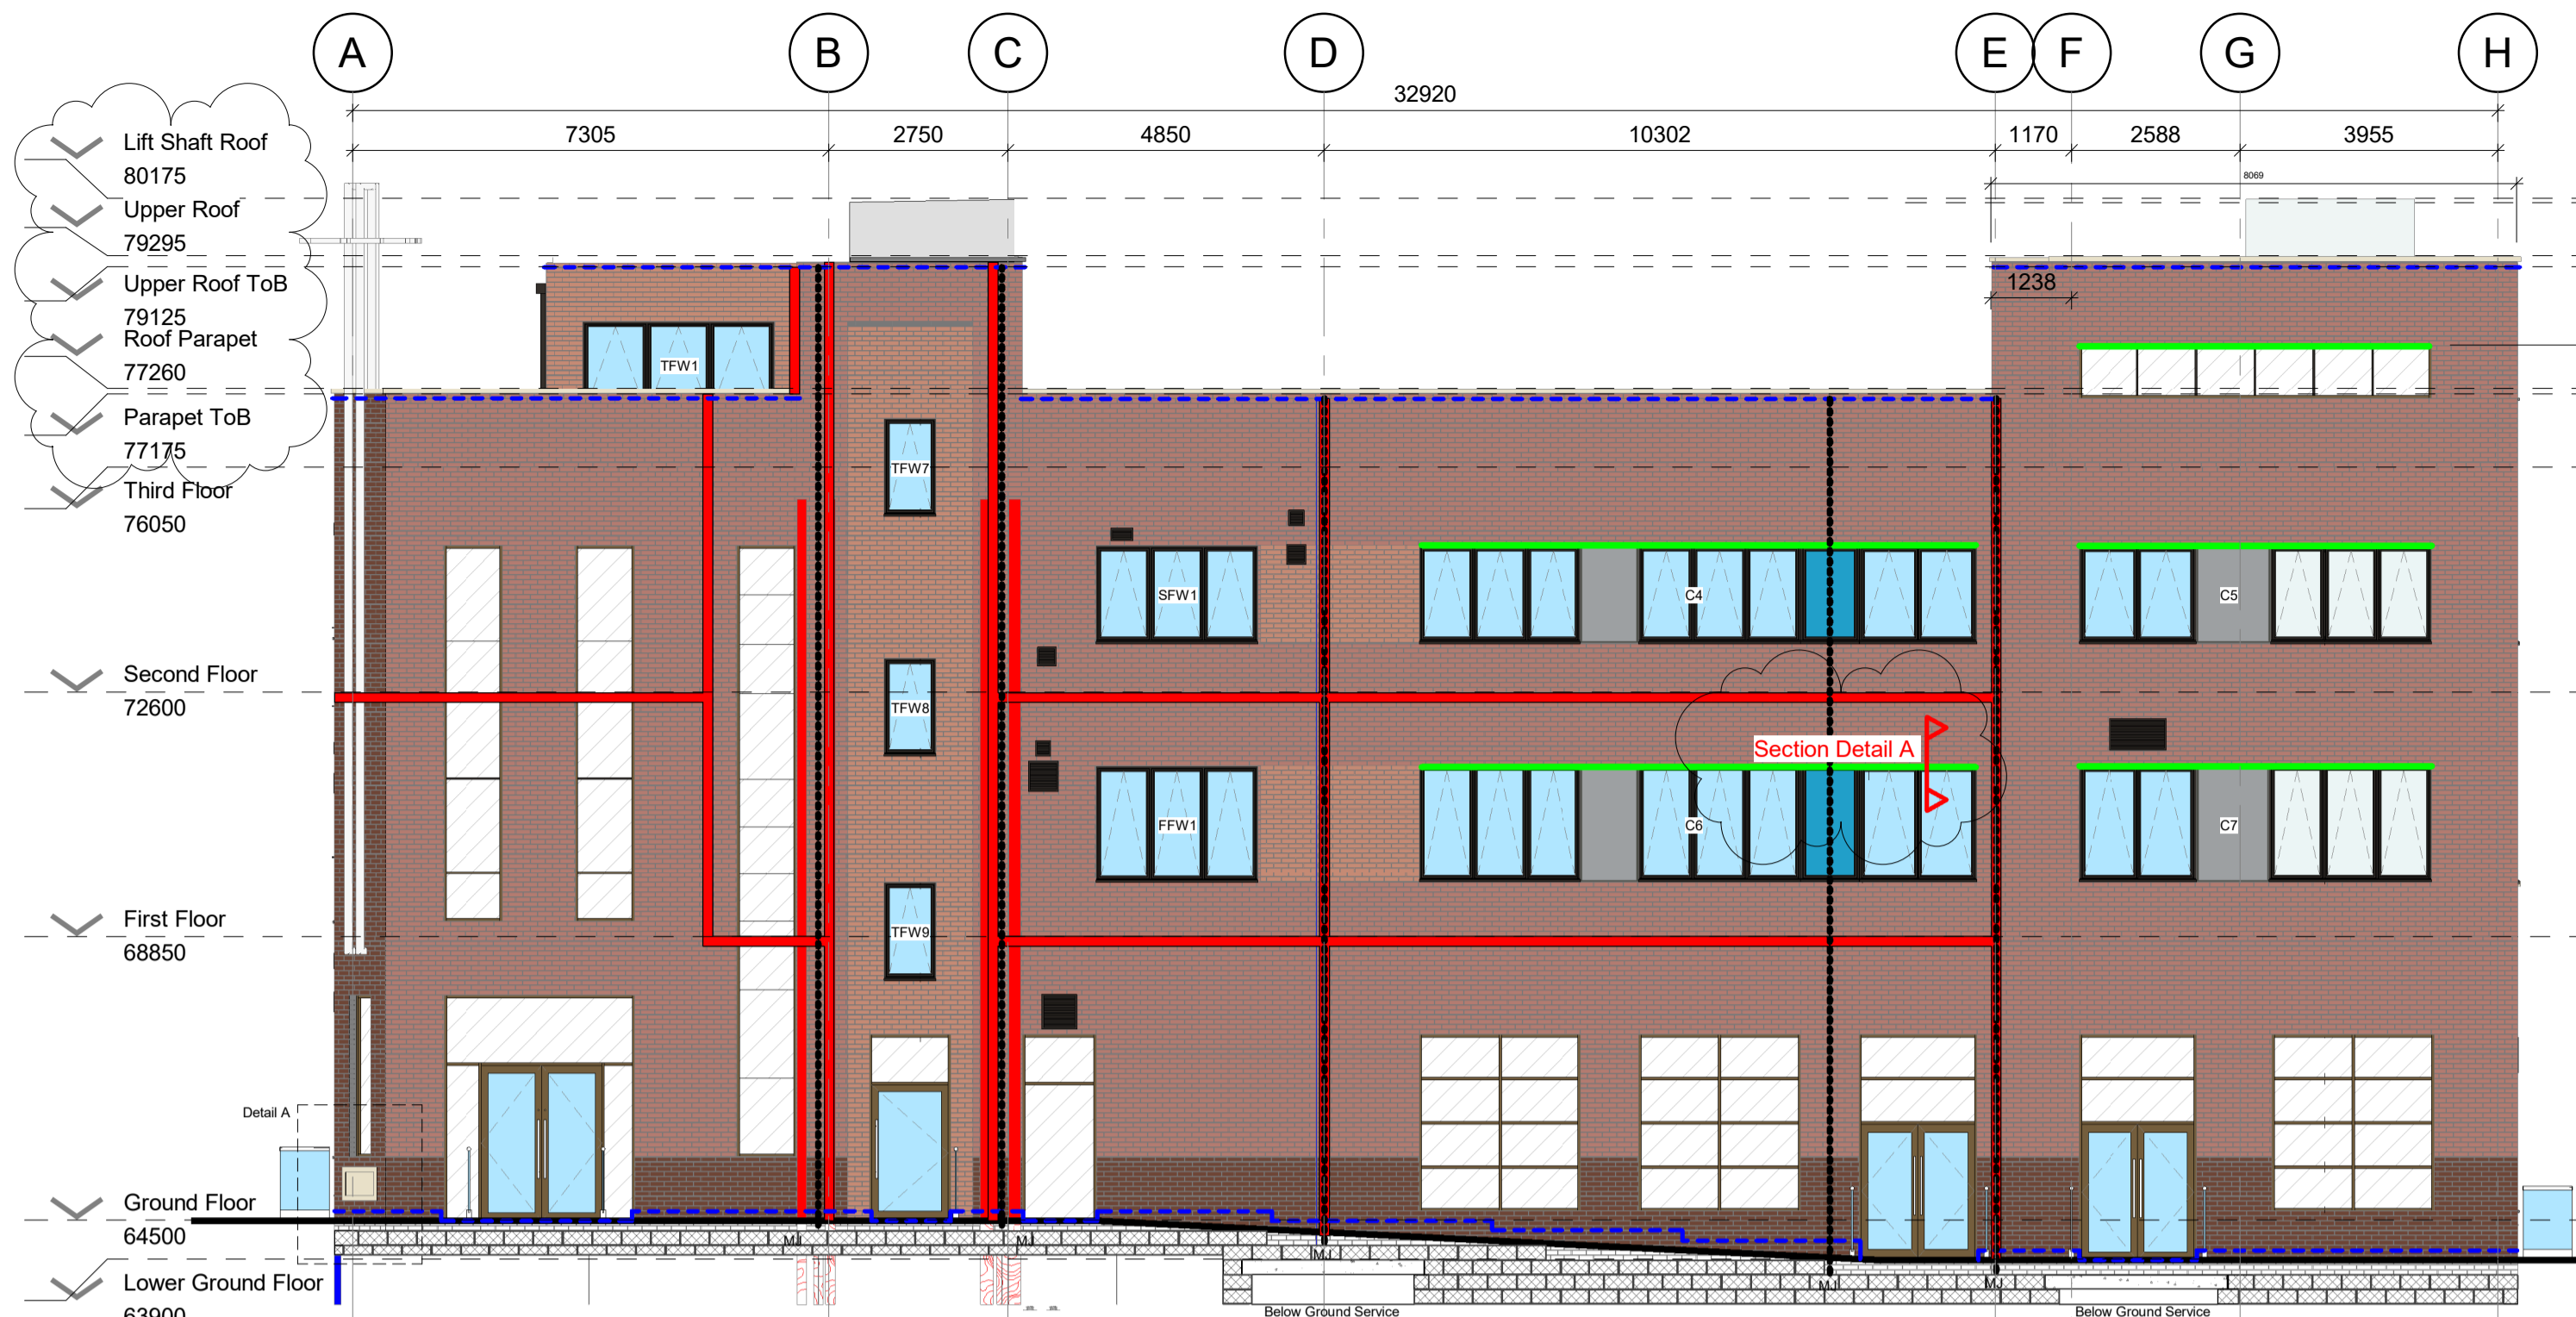
**Elevation A (East) Construction**  
1 : 100

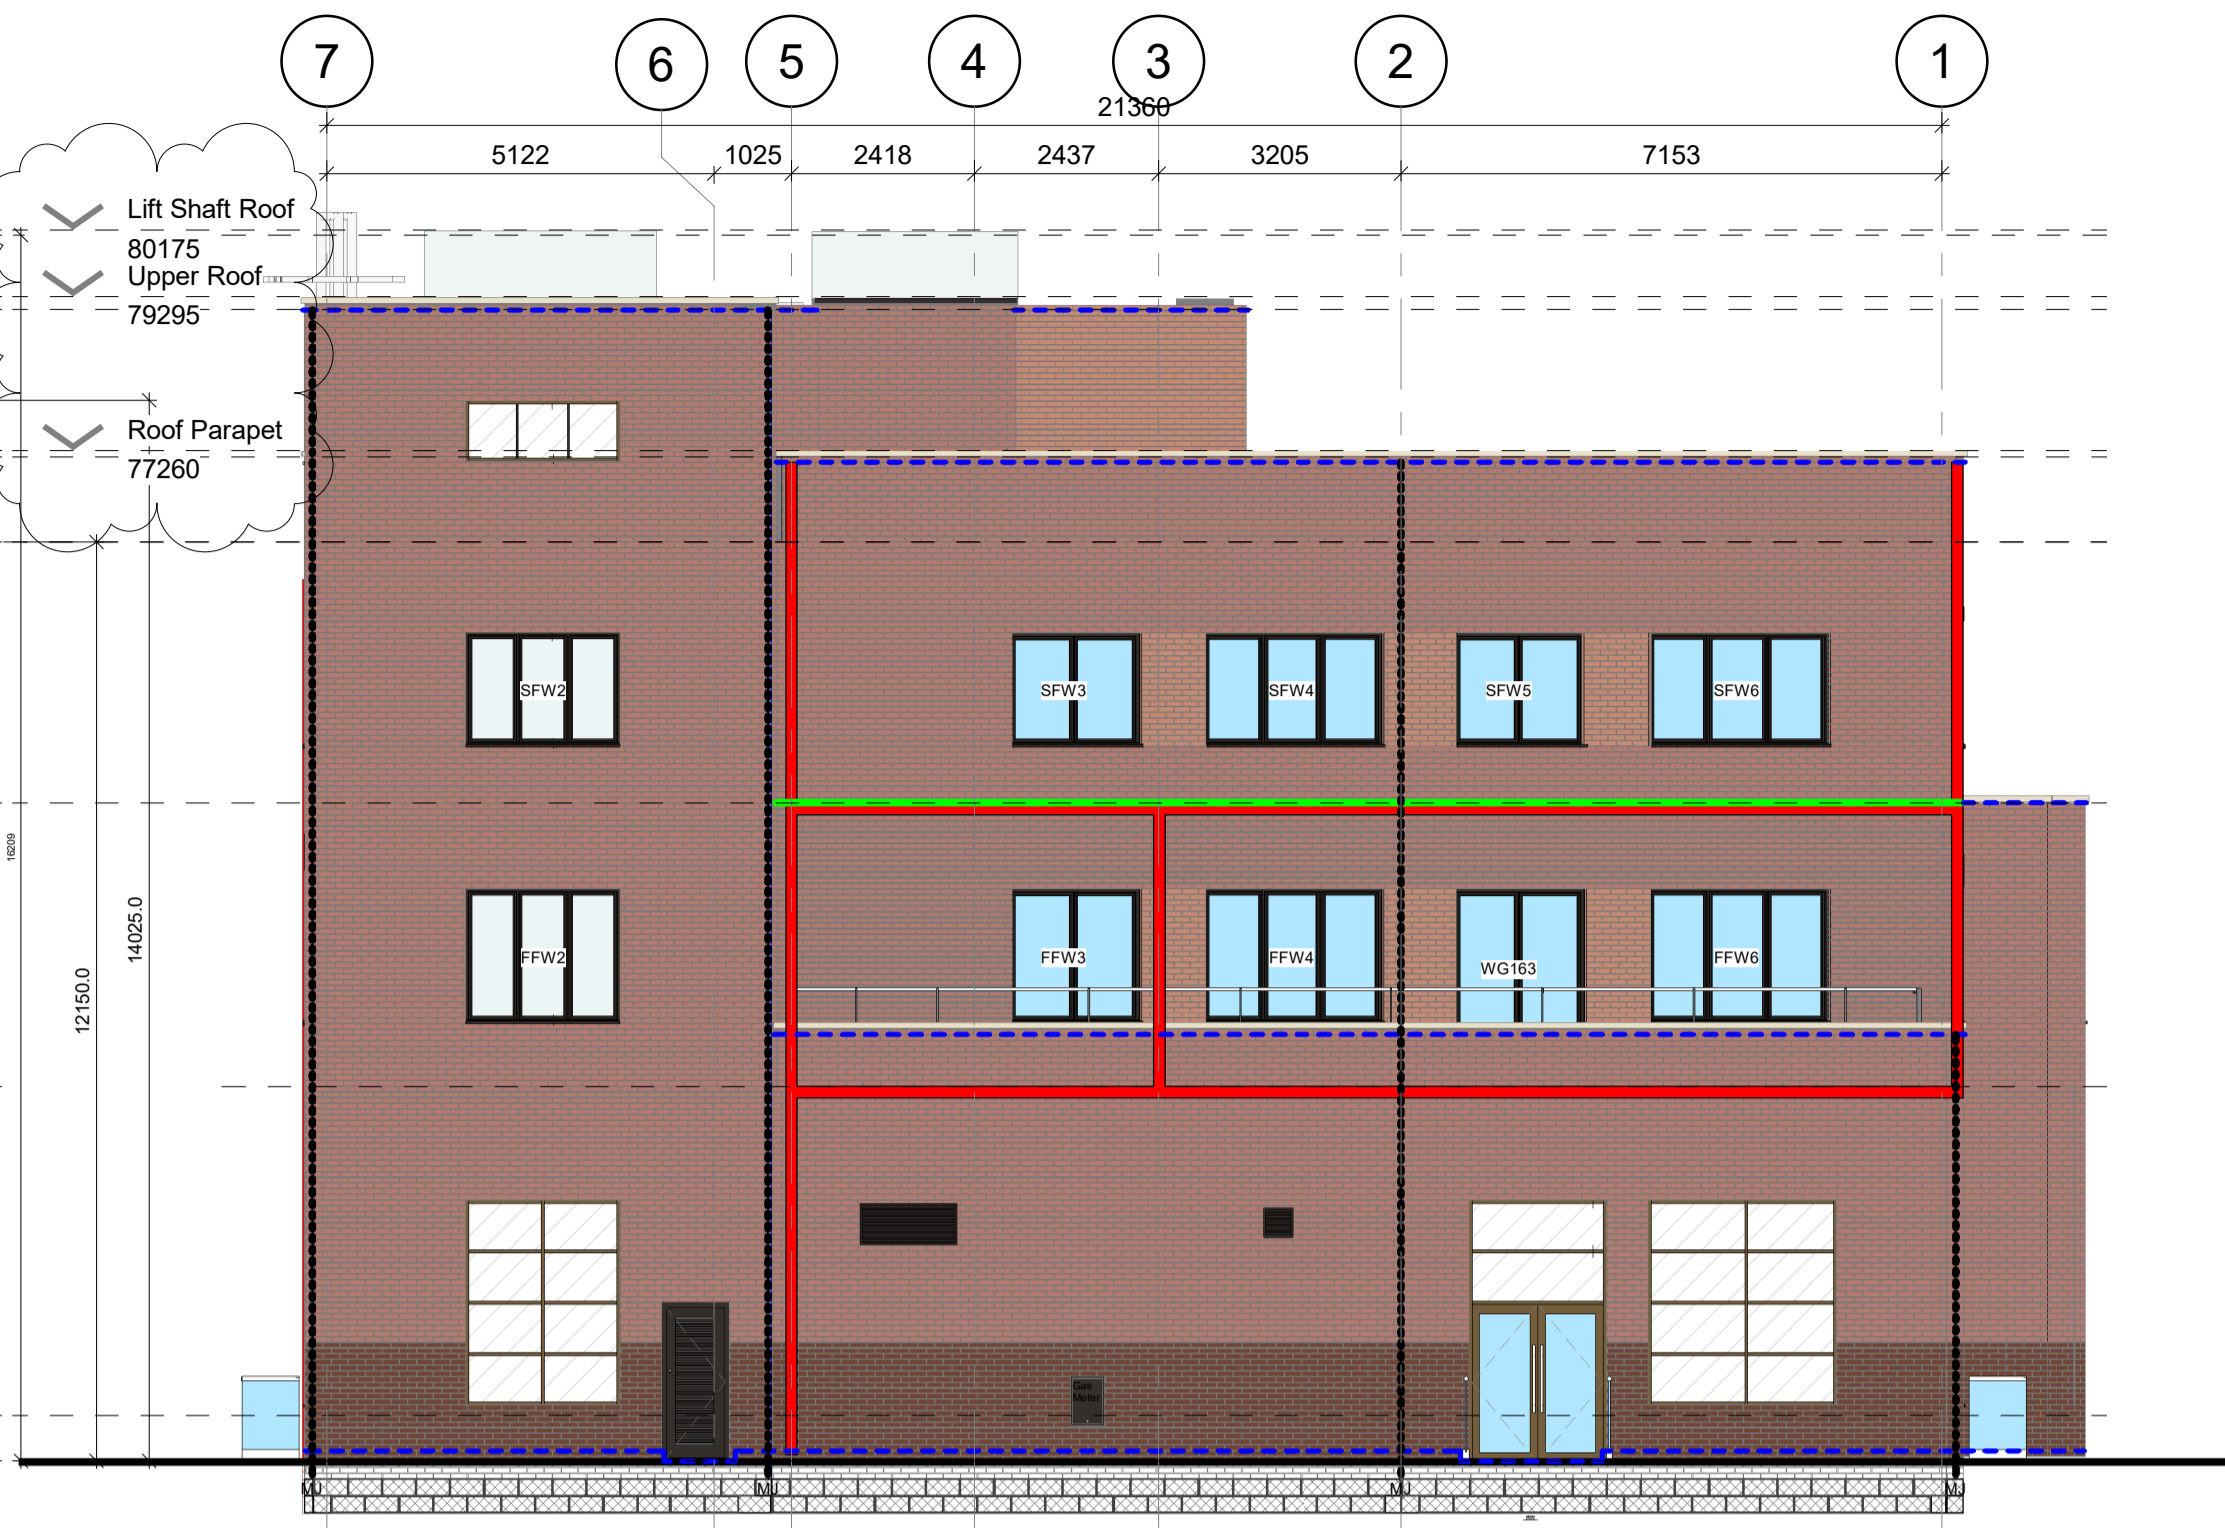
**Elevation B (North) Construction**  
1 : 100

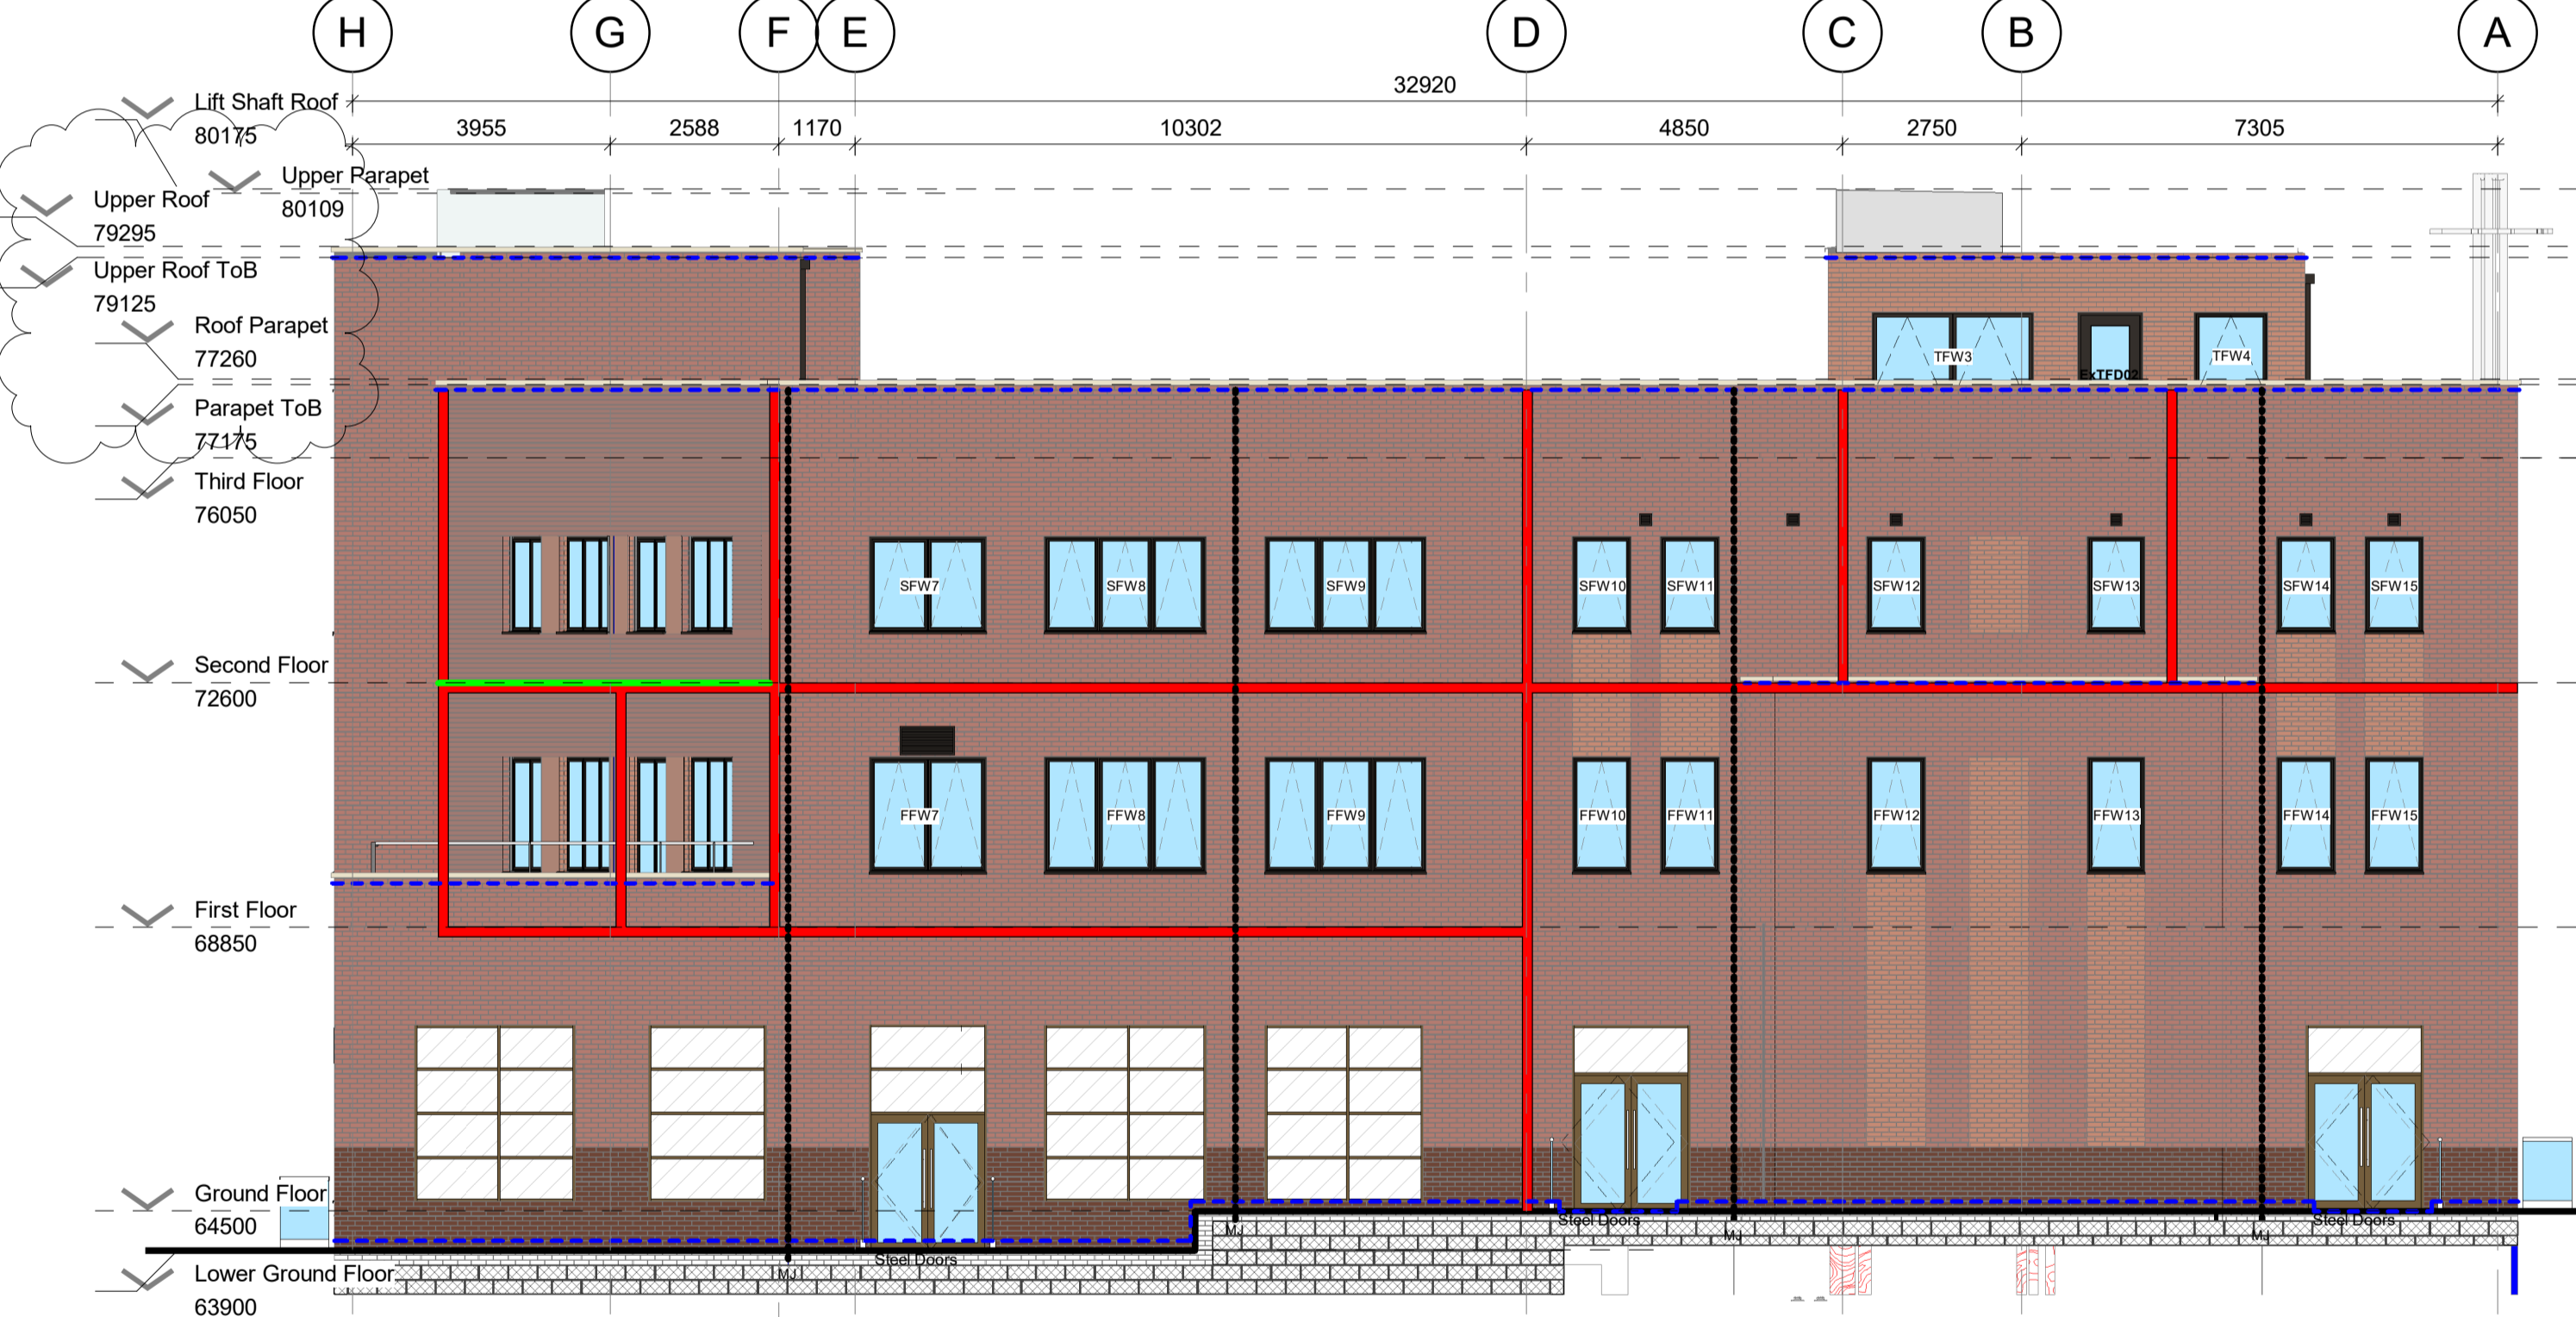
**Elevation C (West) Construction**  
1 : 100

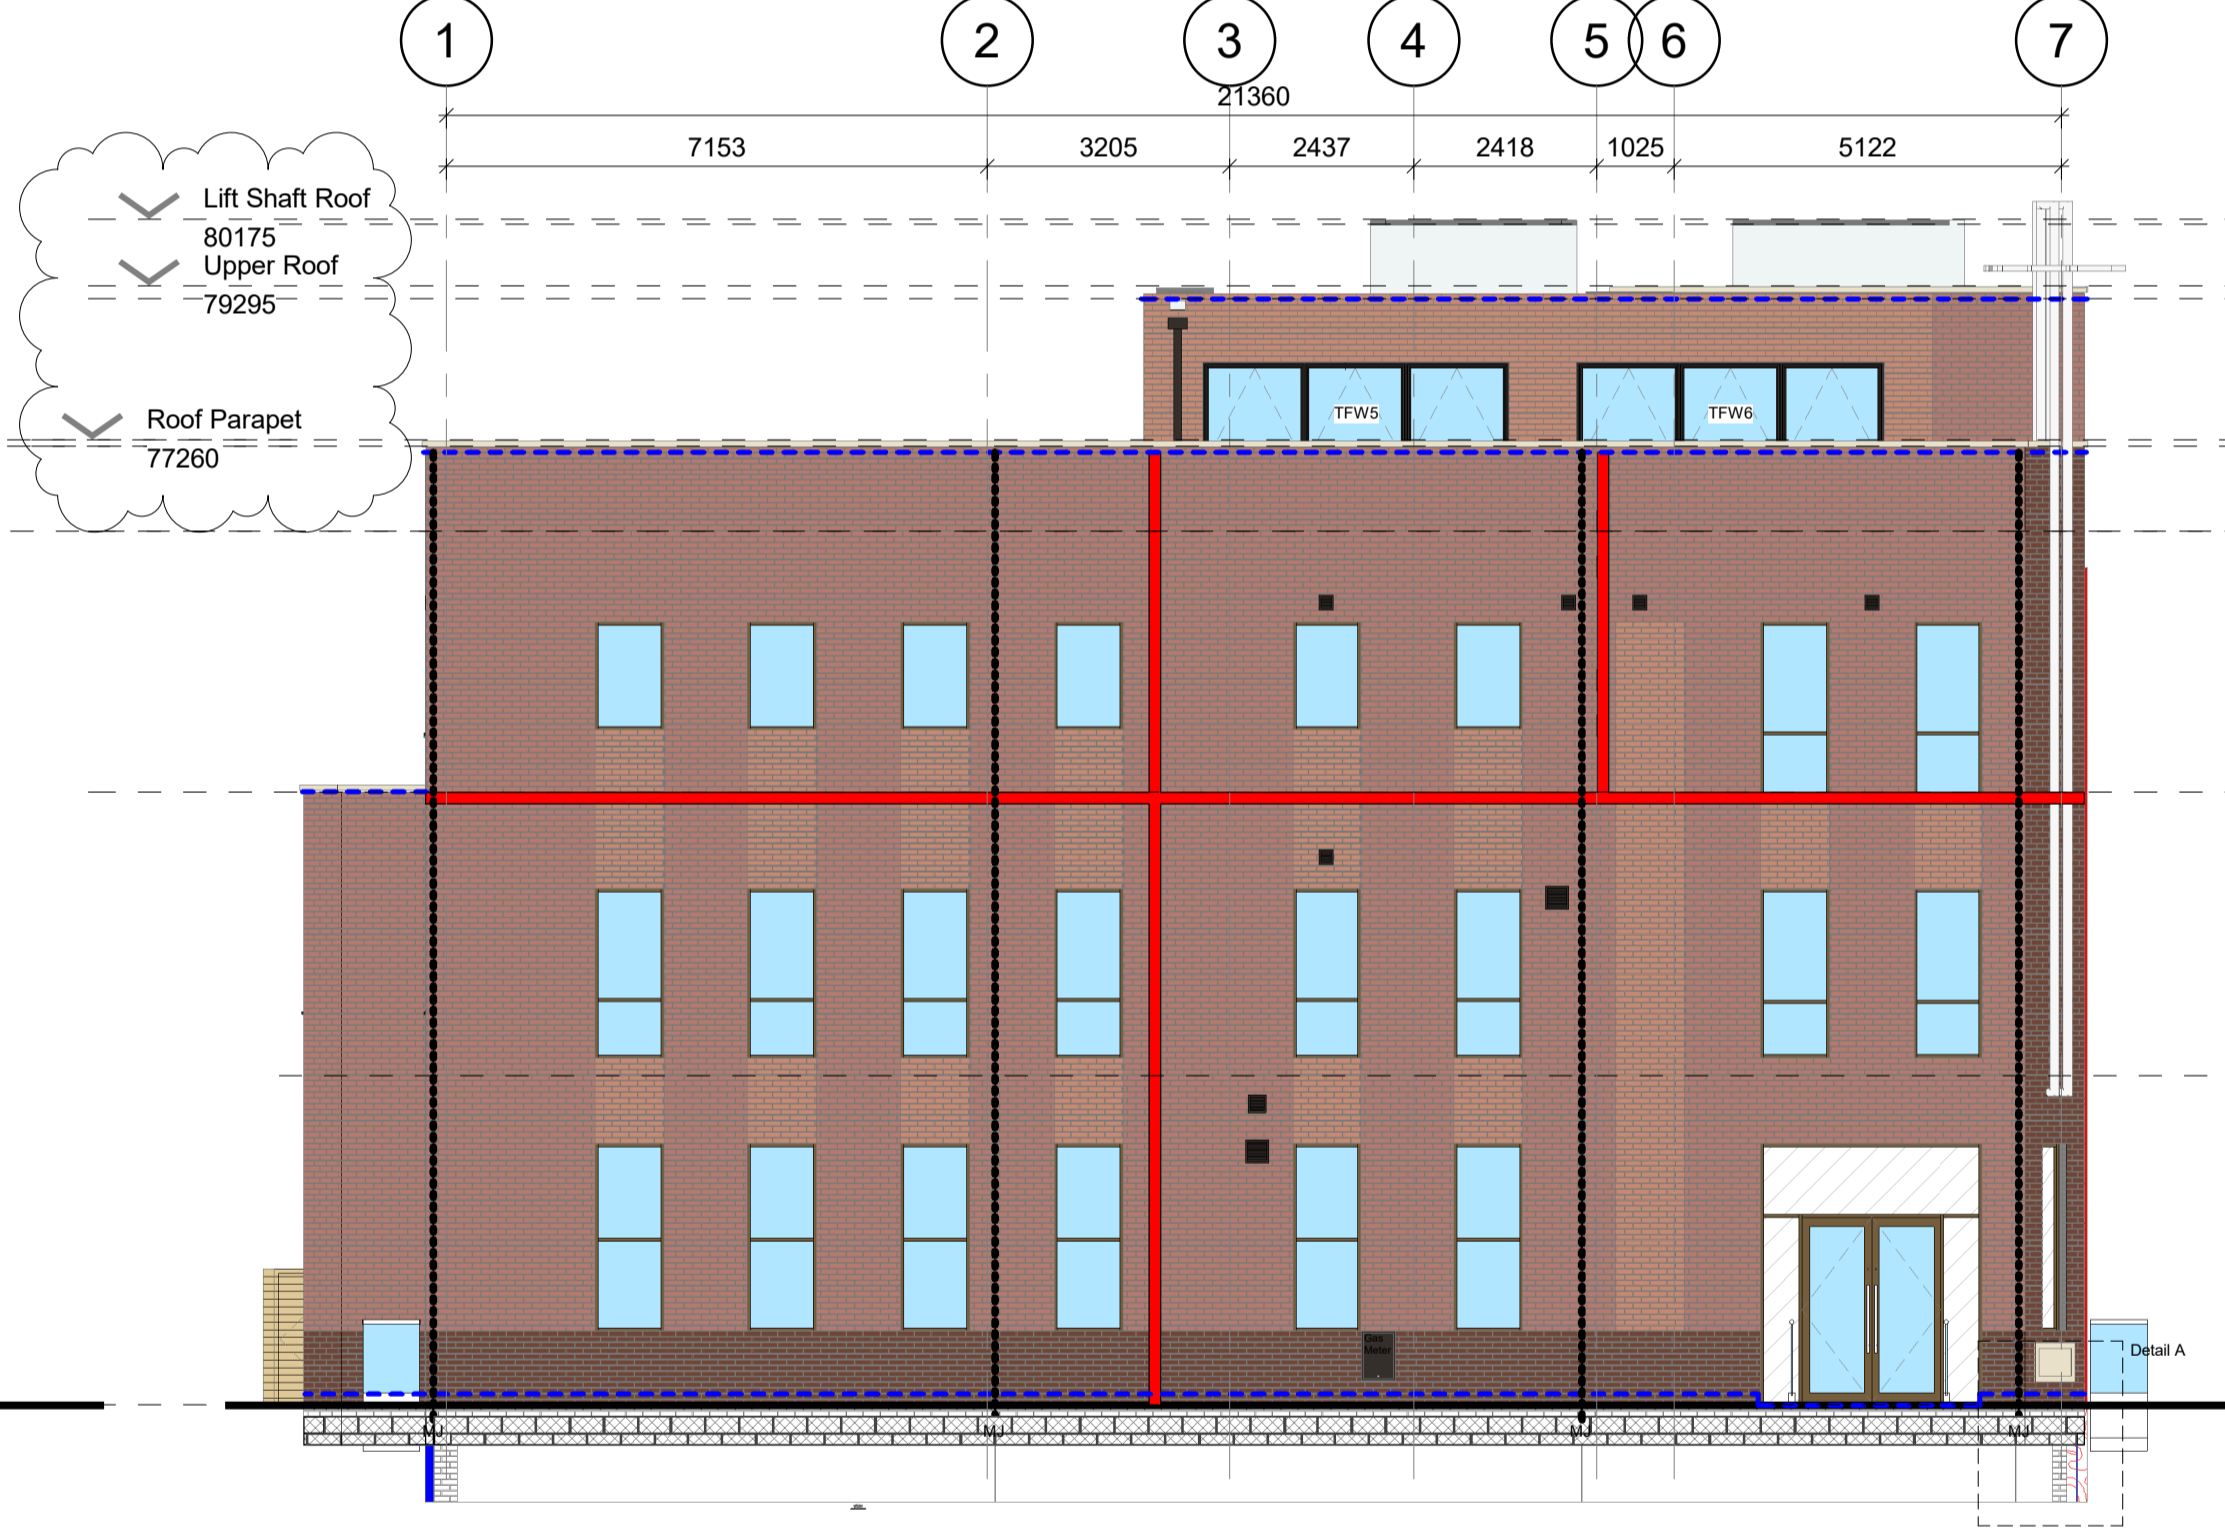
**Elevation D (South) Construction**  
1 : 100

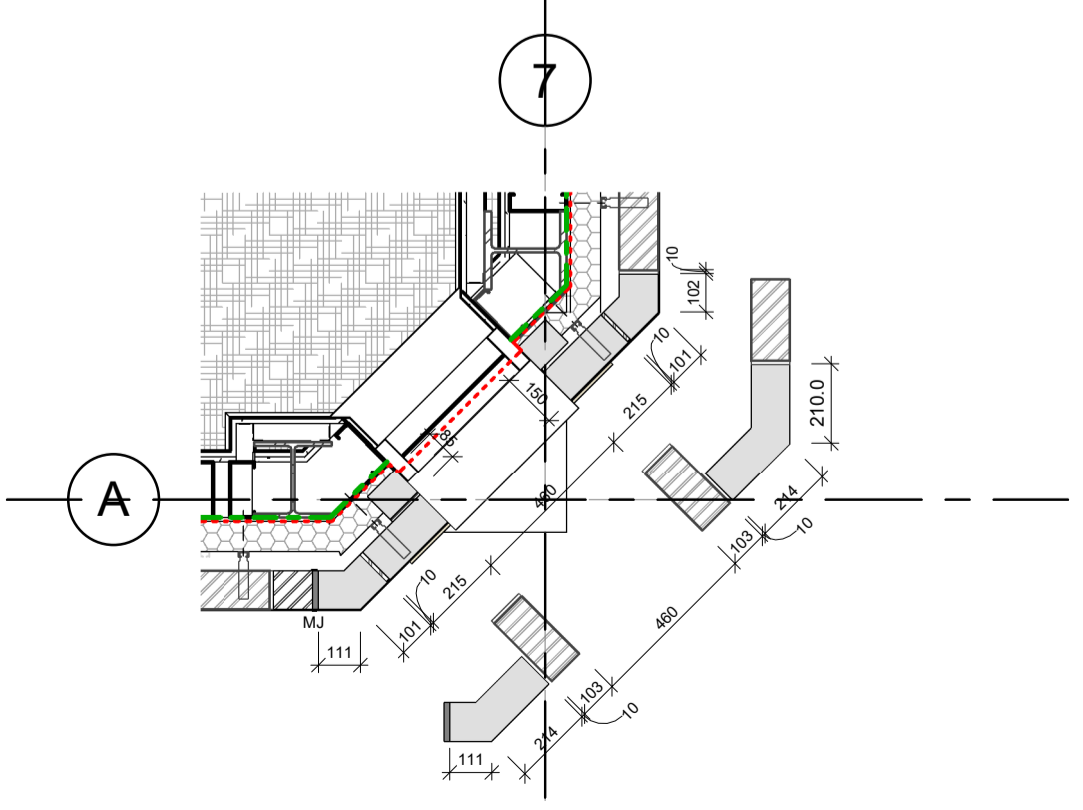
**Cross Corner Feature Brick Details.**  
1 : 20

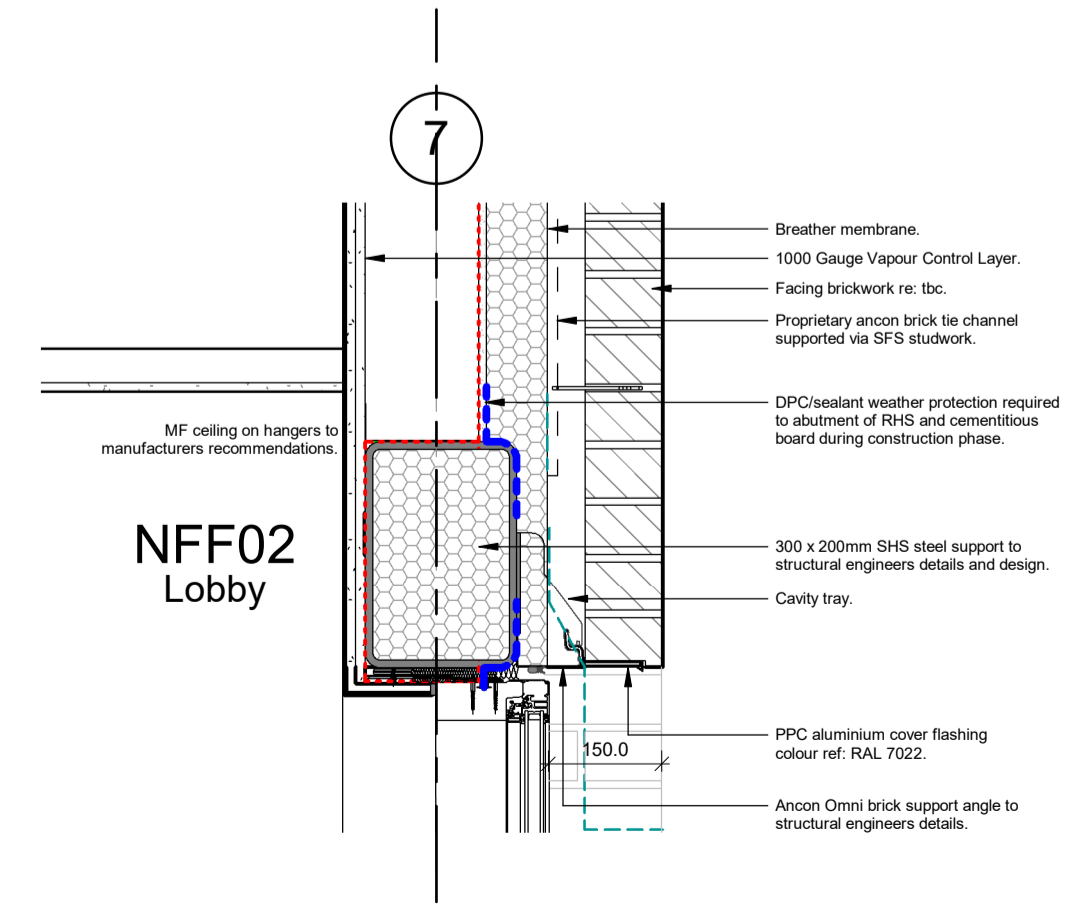
**Detail Section A - Pistol Brick Window Lintel Type**  
1 : 10
